大丸ピーコック EIFS-J改修工事

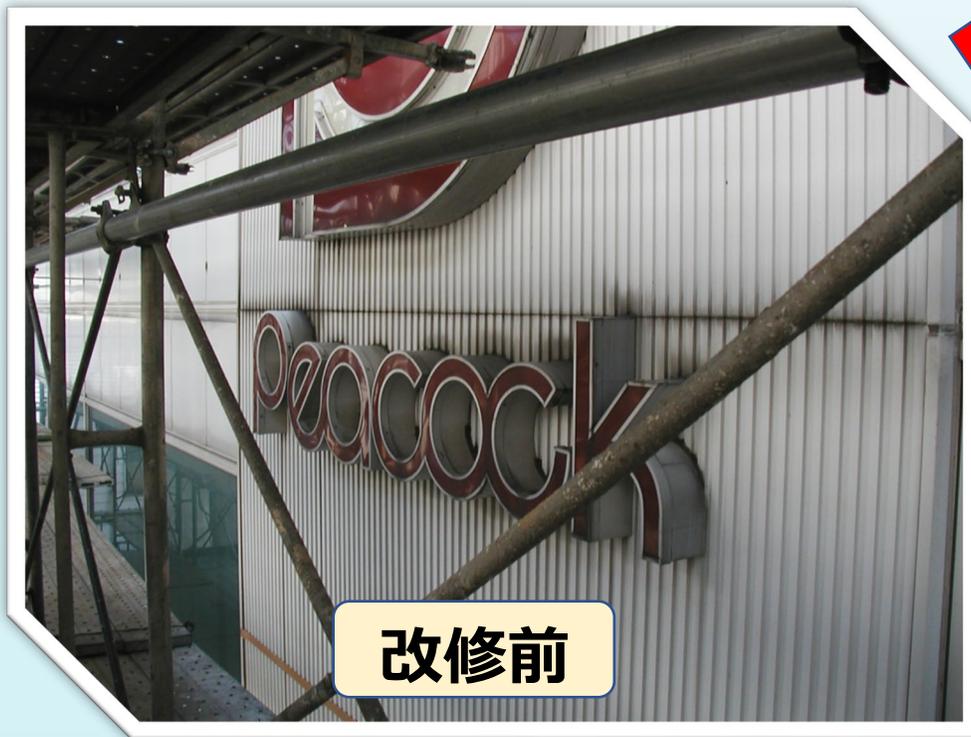
改修前

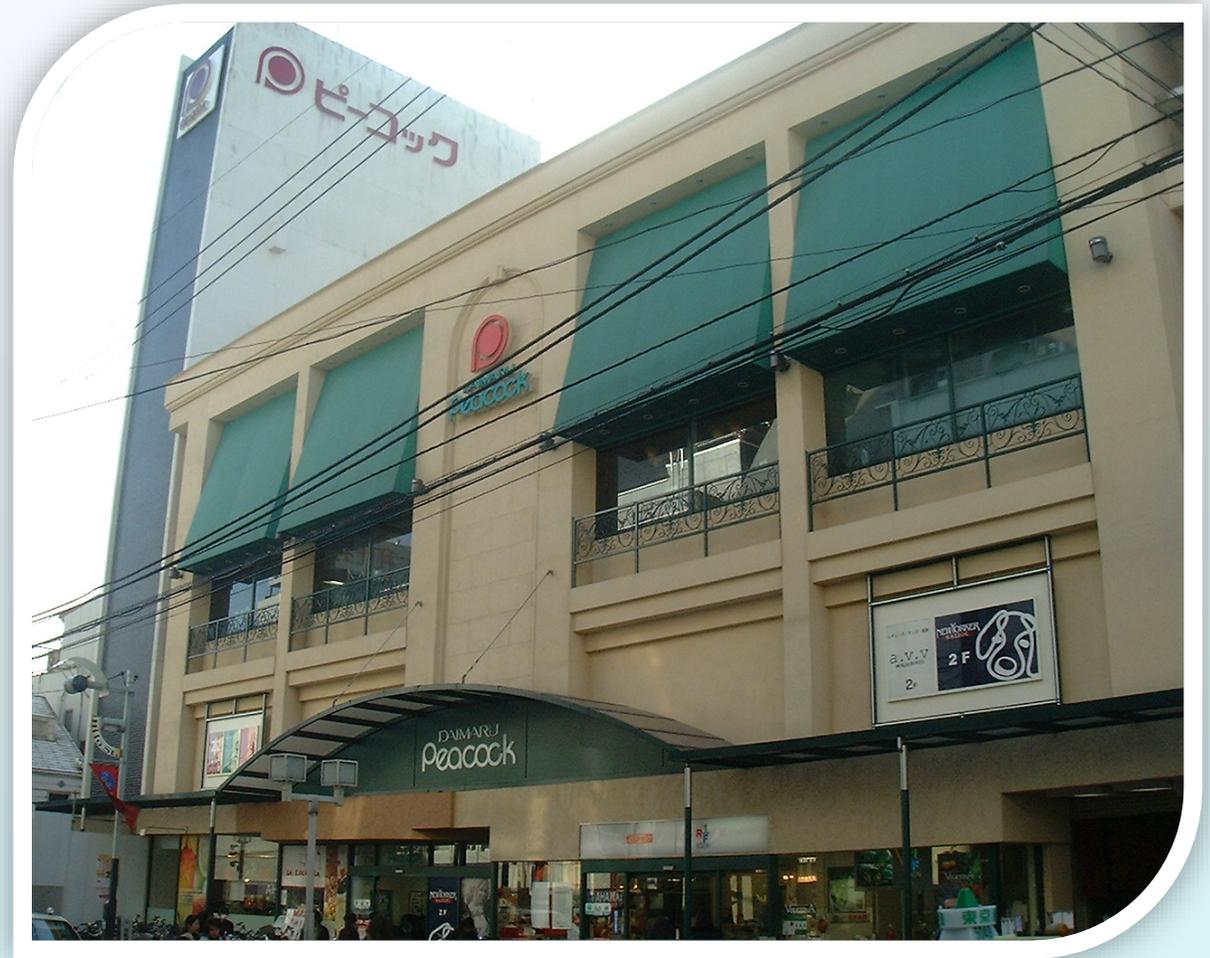
改修後

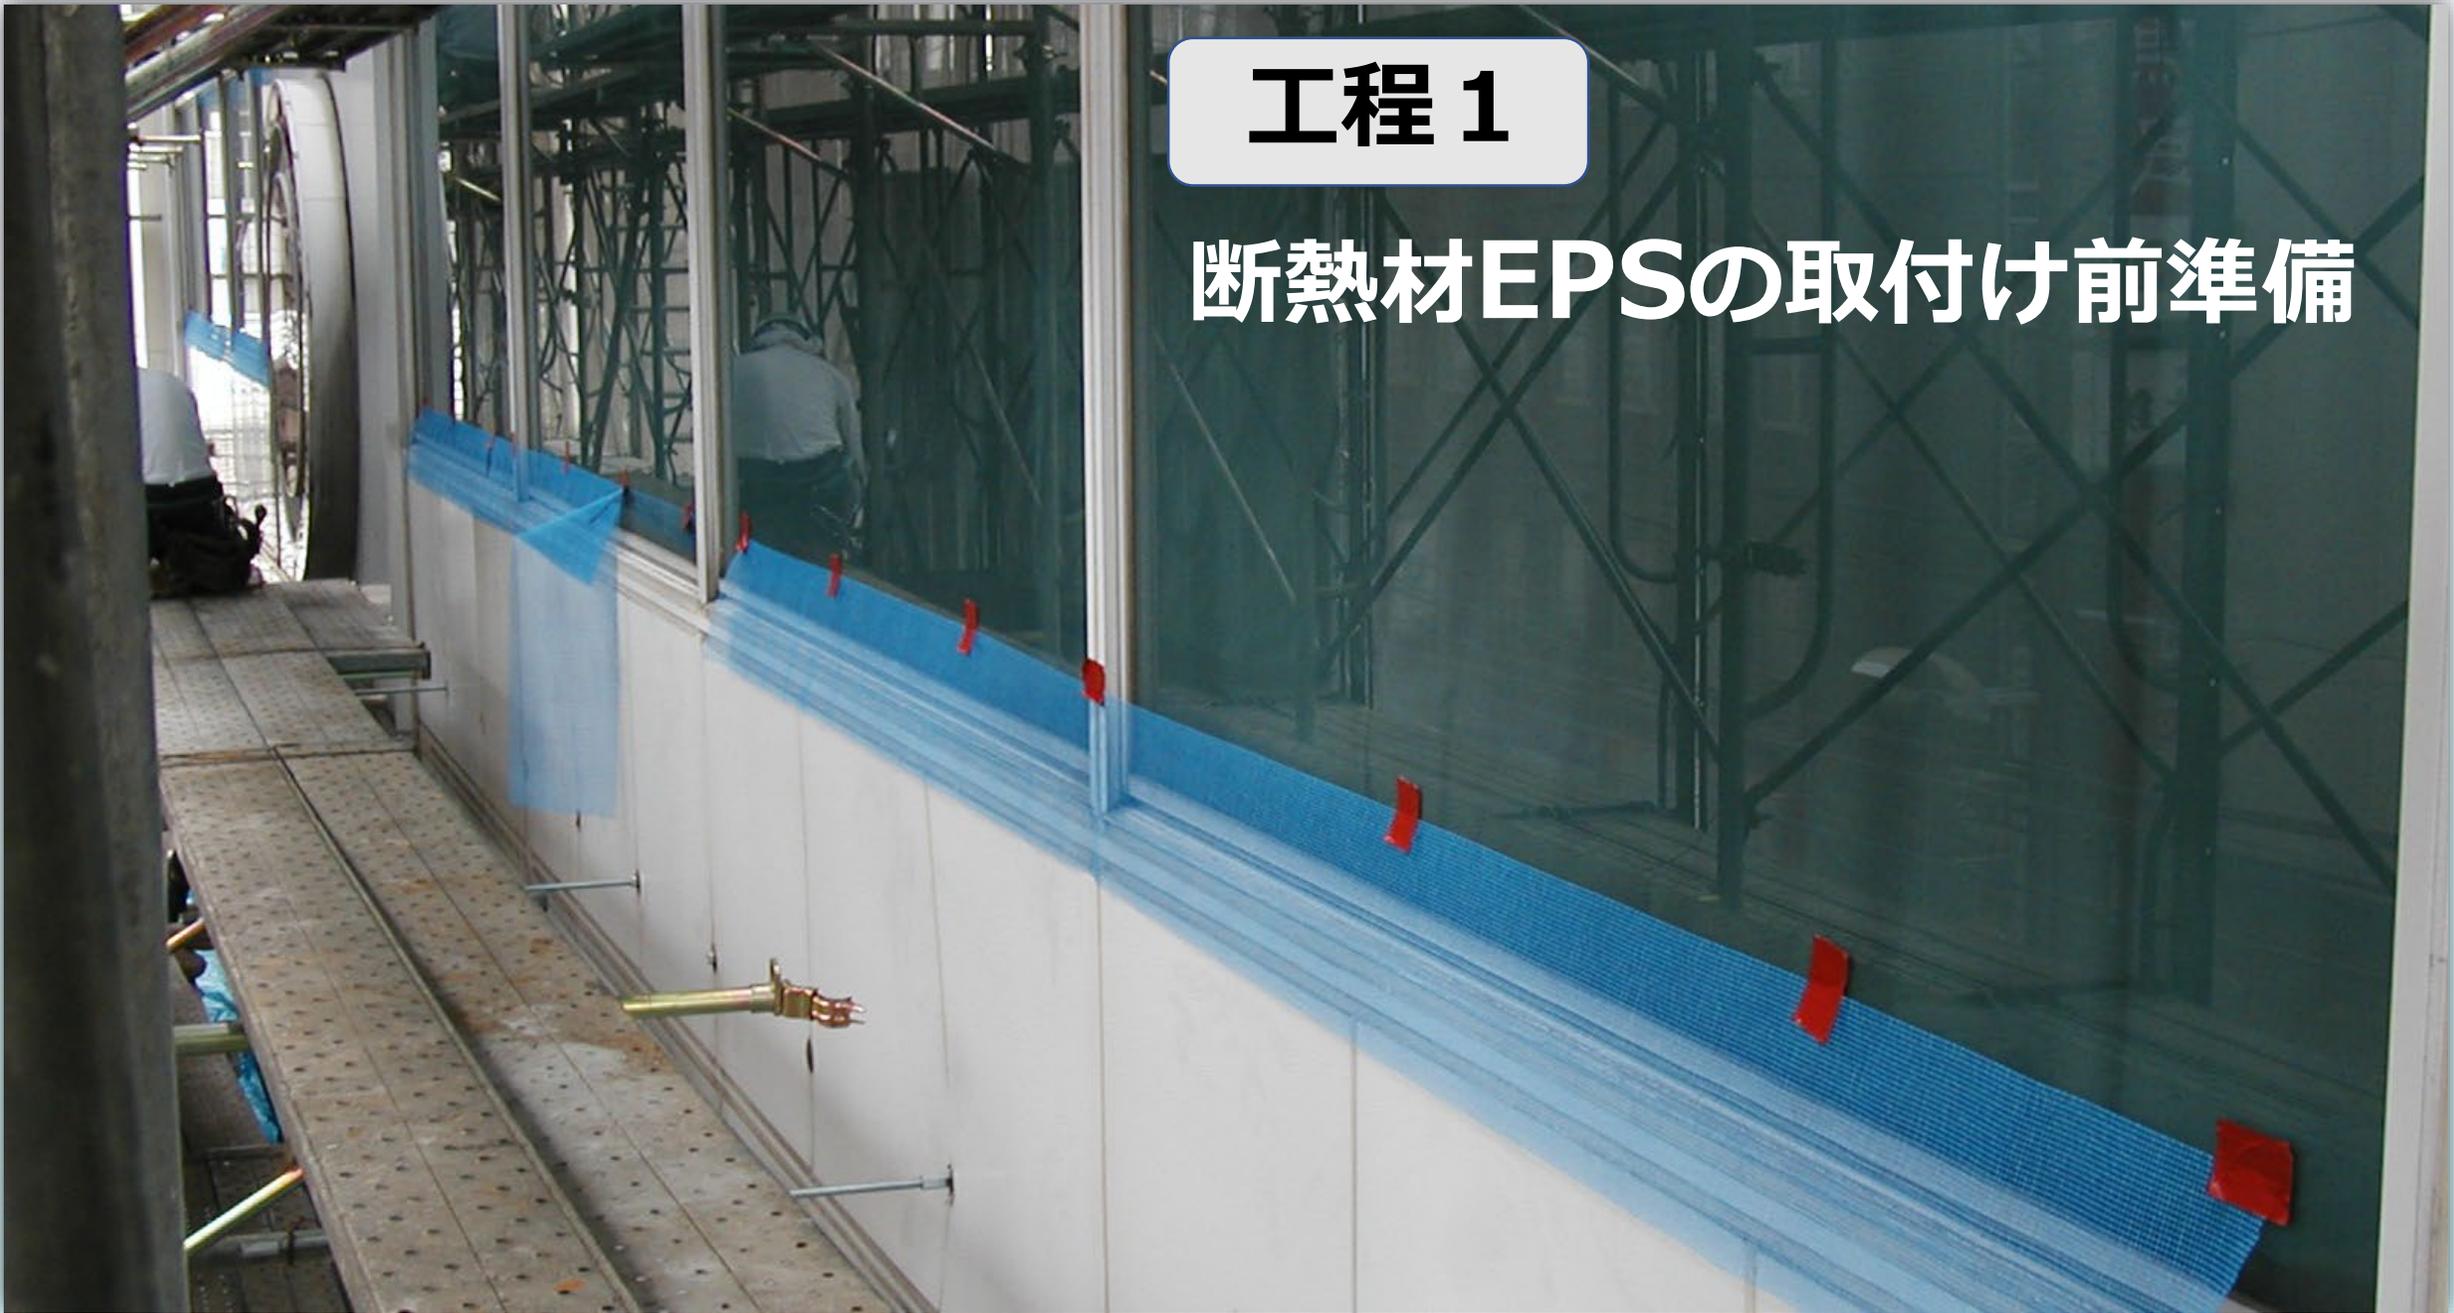
工程 1

断熱材EPSの取付け前準備

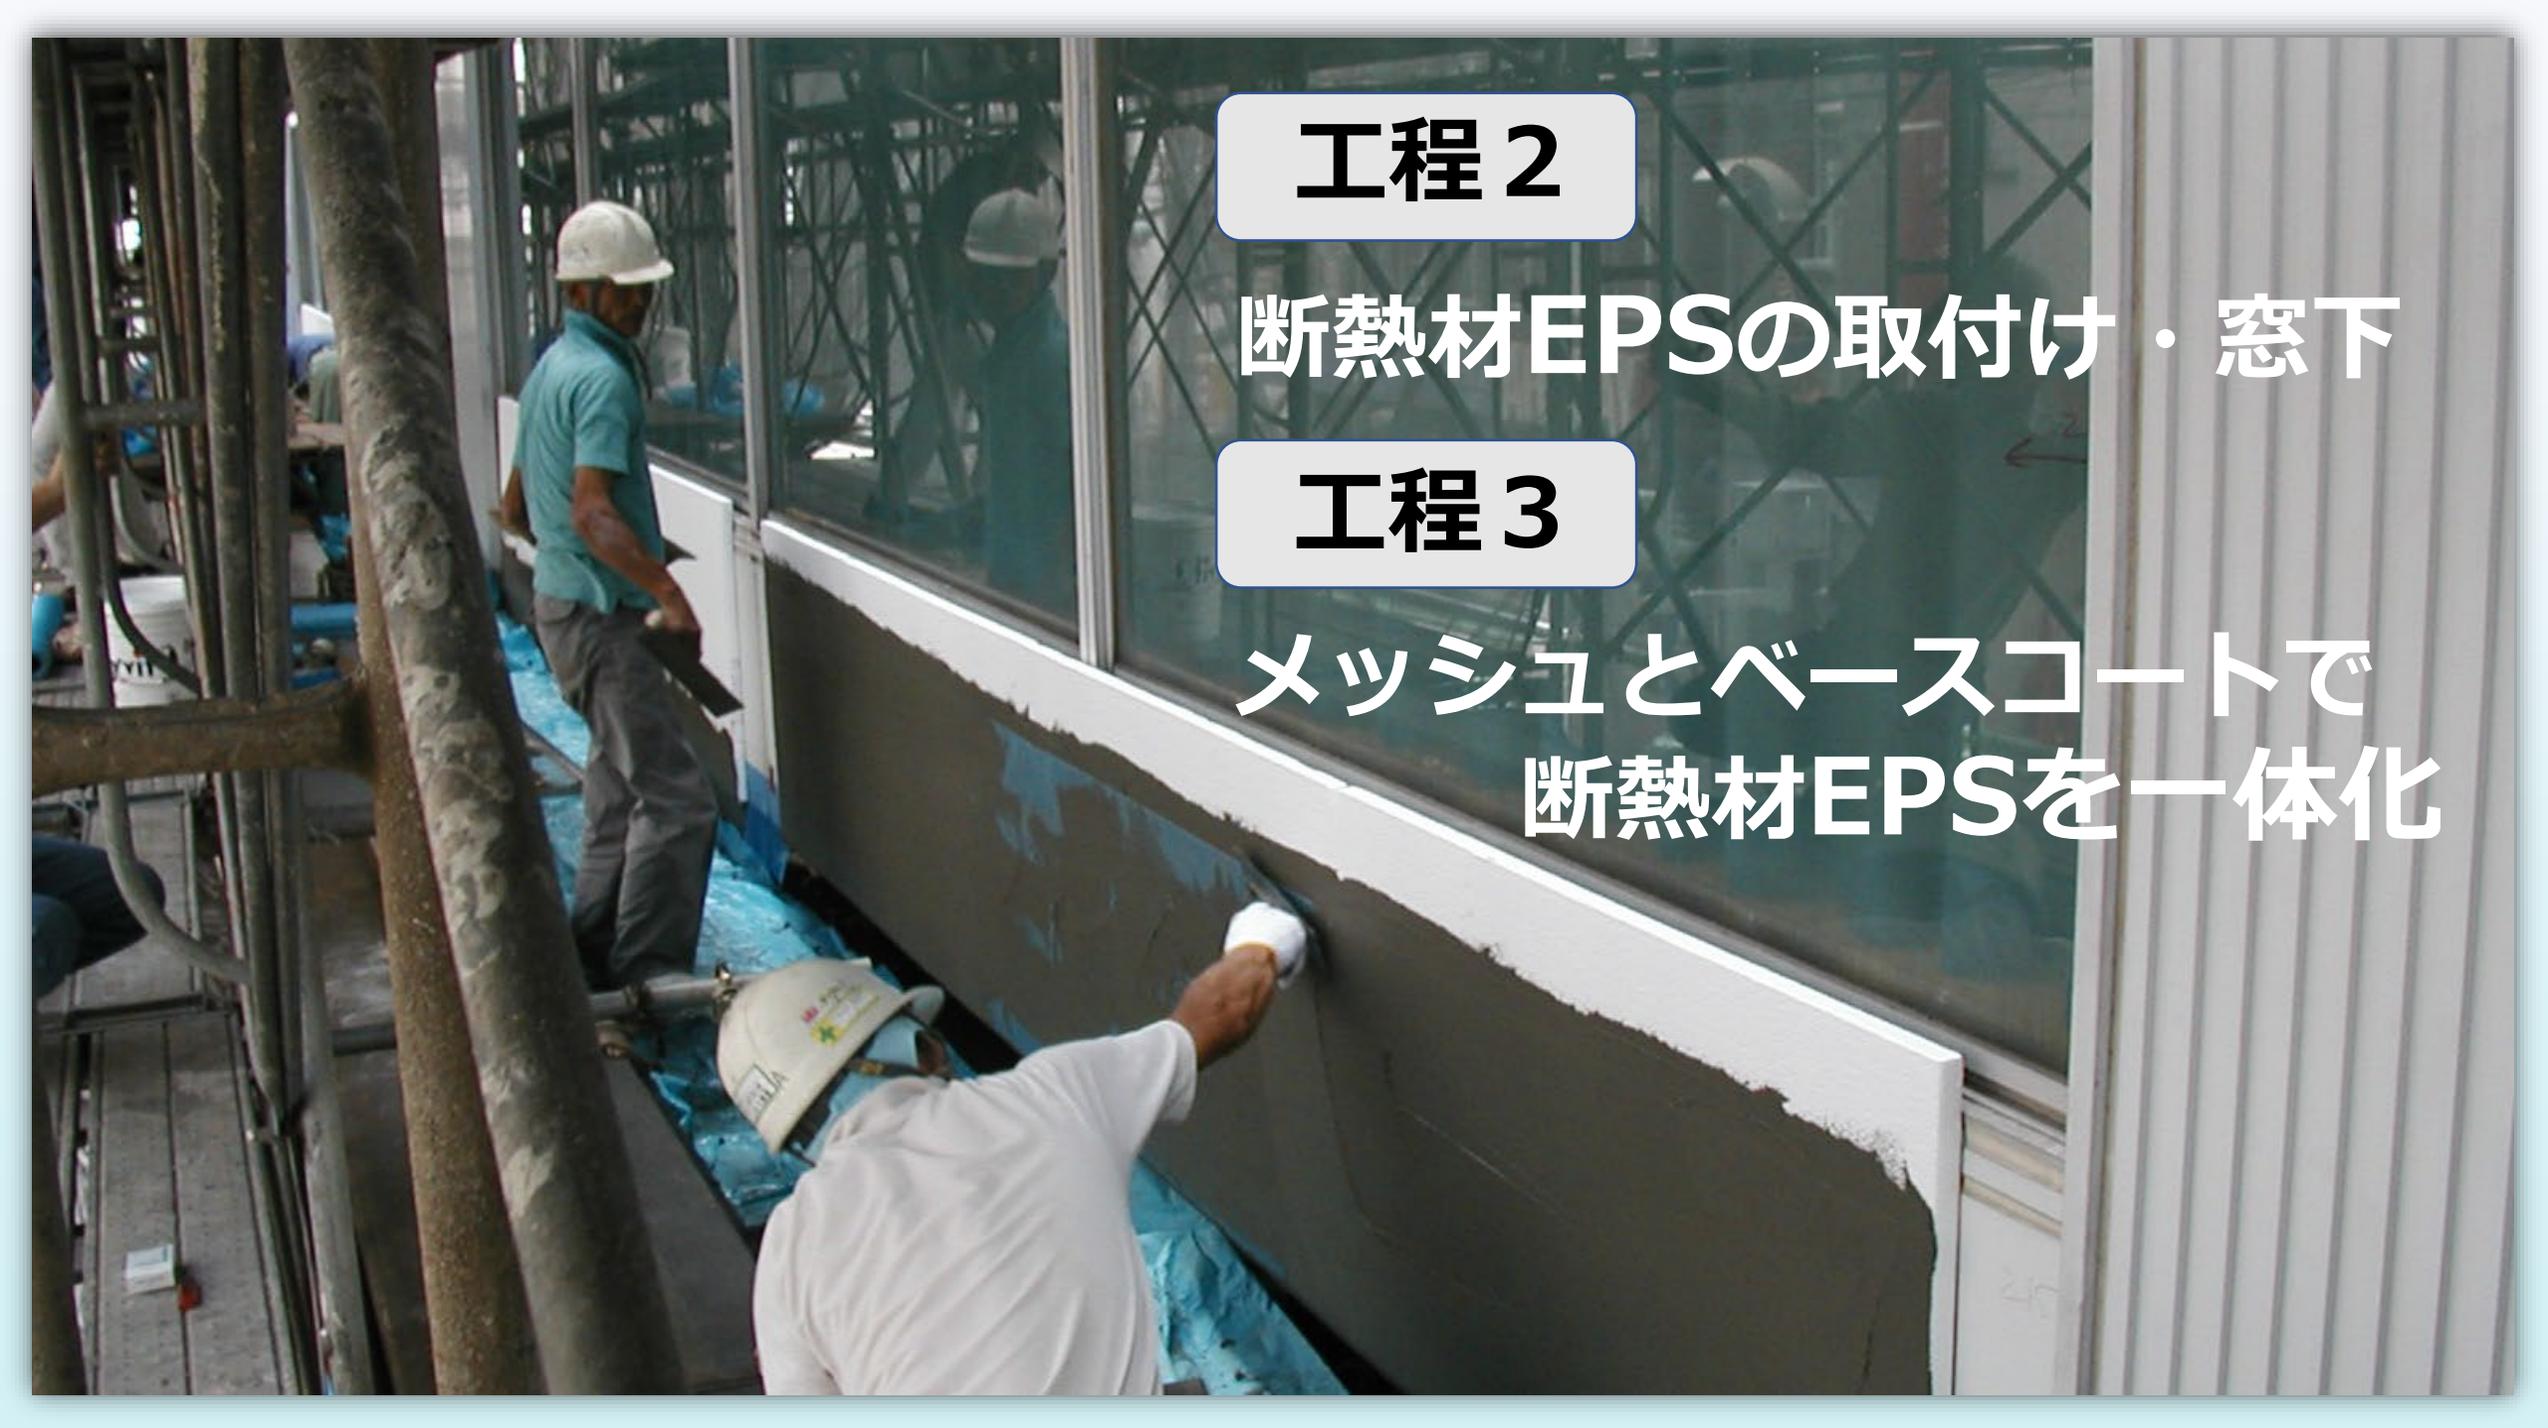
工程 2

A construction site showing workers on a scaffolding installing EPS insulation under a window. One worker in a white shirt and hard hat is applying a grey mesh to a dark grey base coat on the wall. Another worker in a light blue shirt and hard hat is standing nearby. The window is large and has a metal frame. The scaffolding is made of metal pipes and has a blue safety netting.

断熱材EPSの取付け・窓下

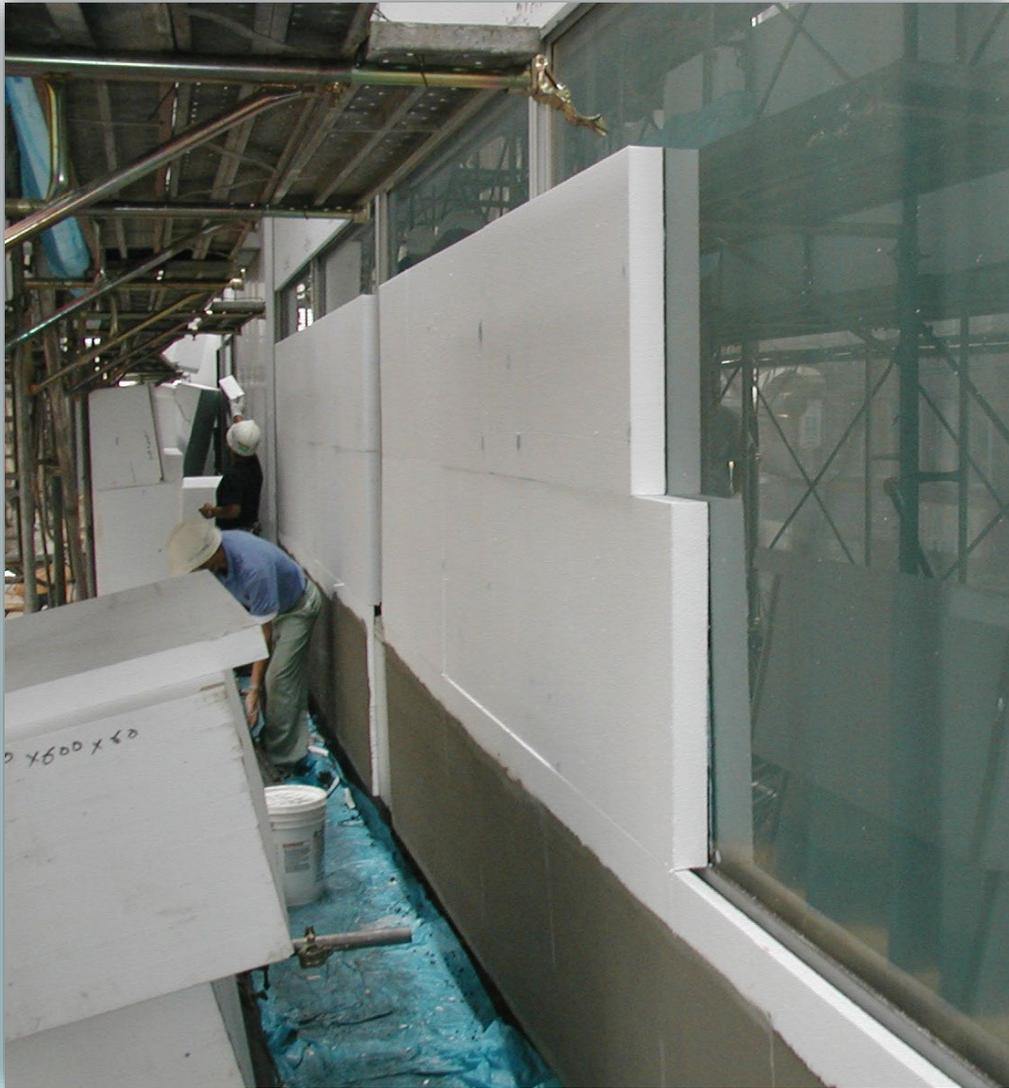
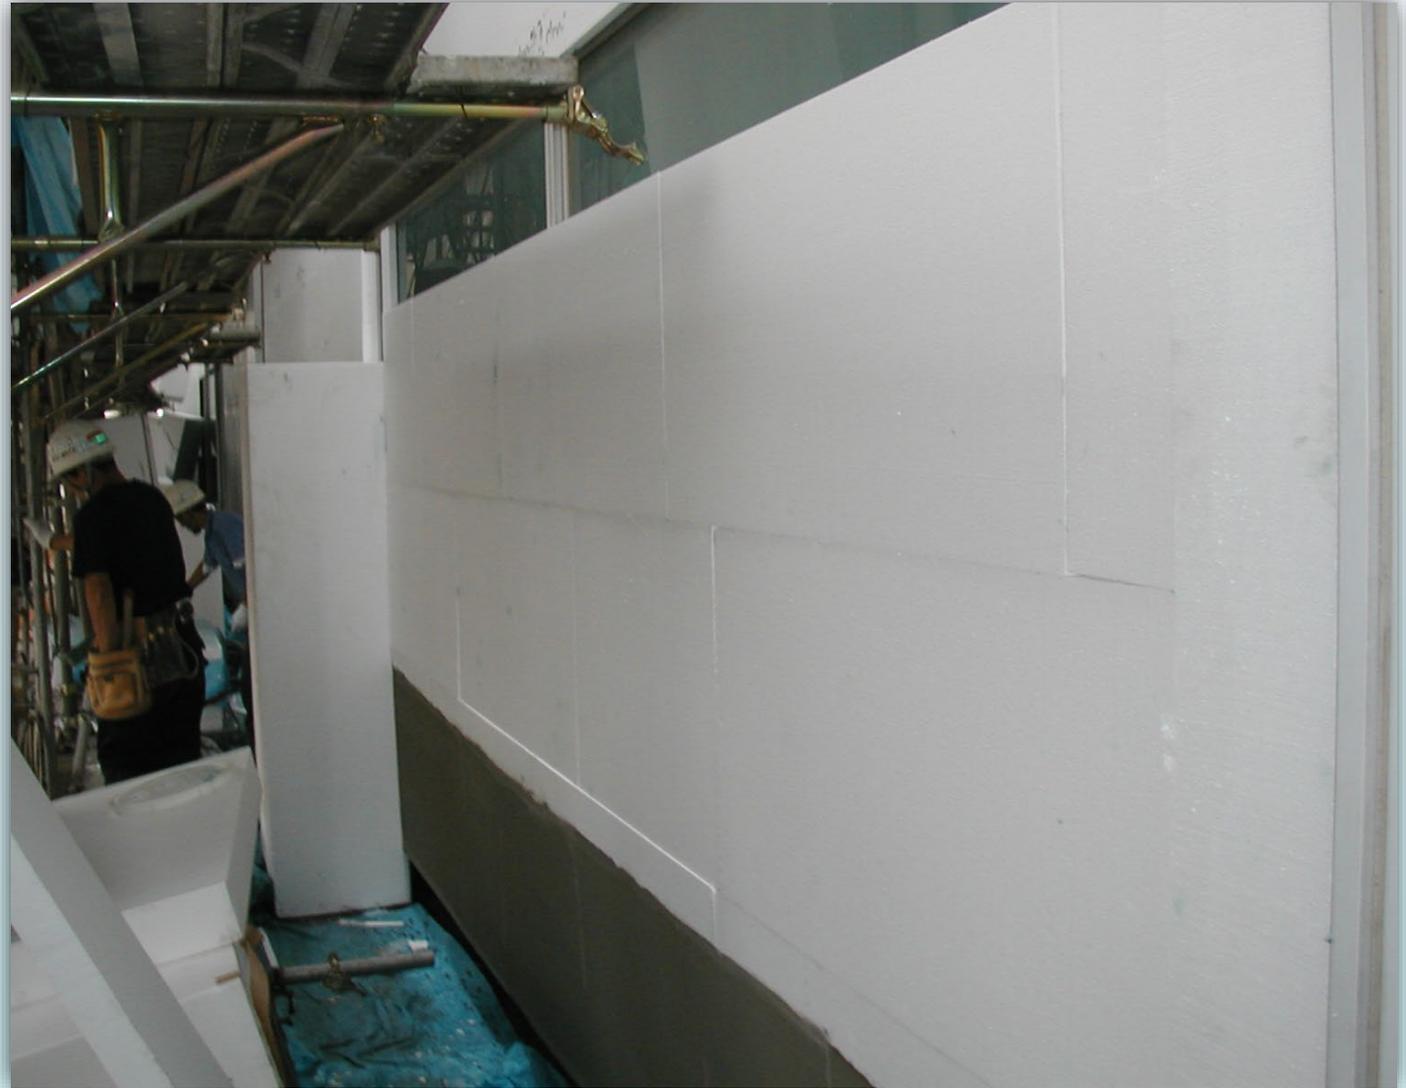
工程 4

窓への断熱材EPSの取付け

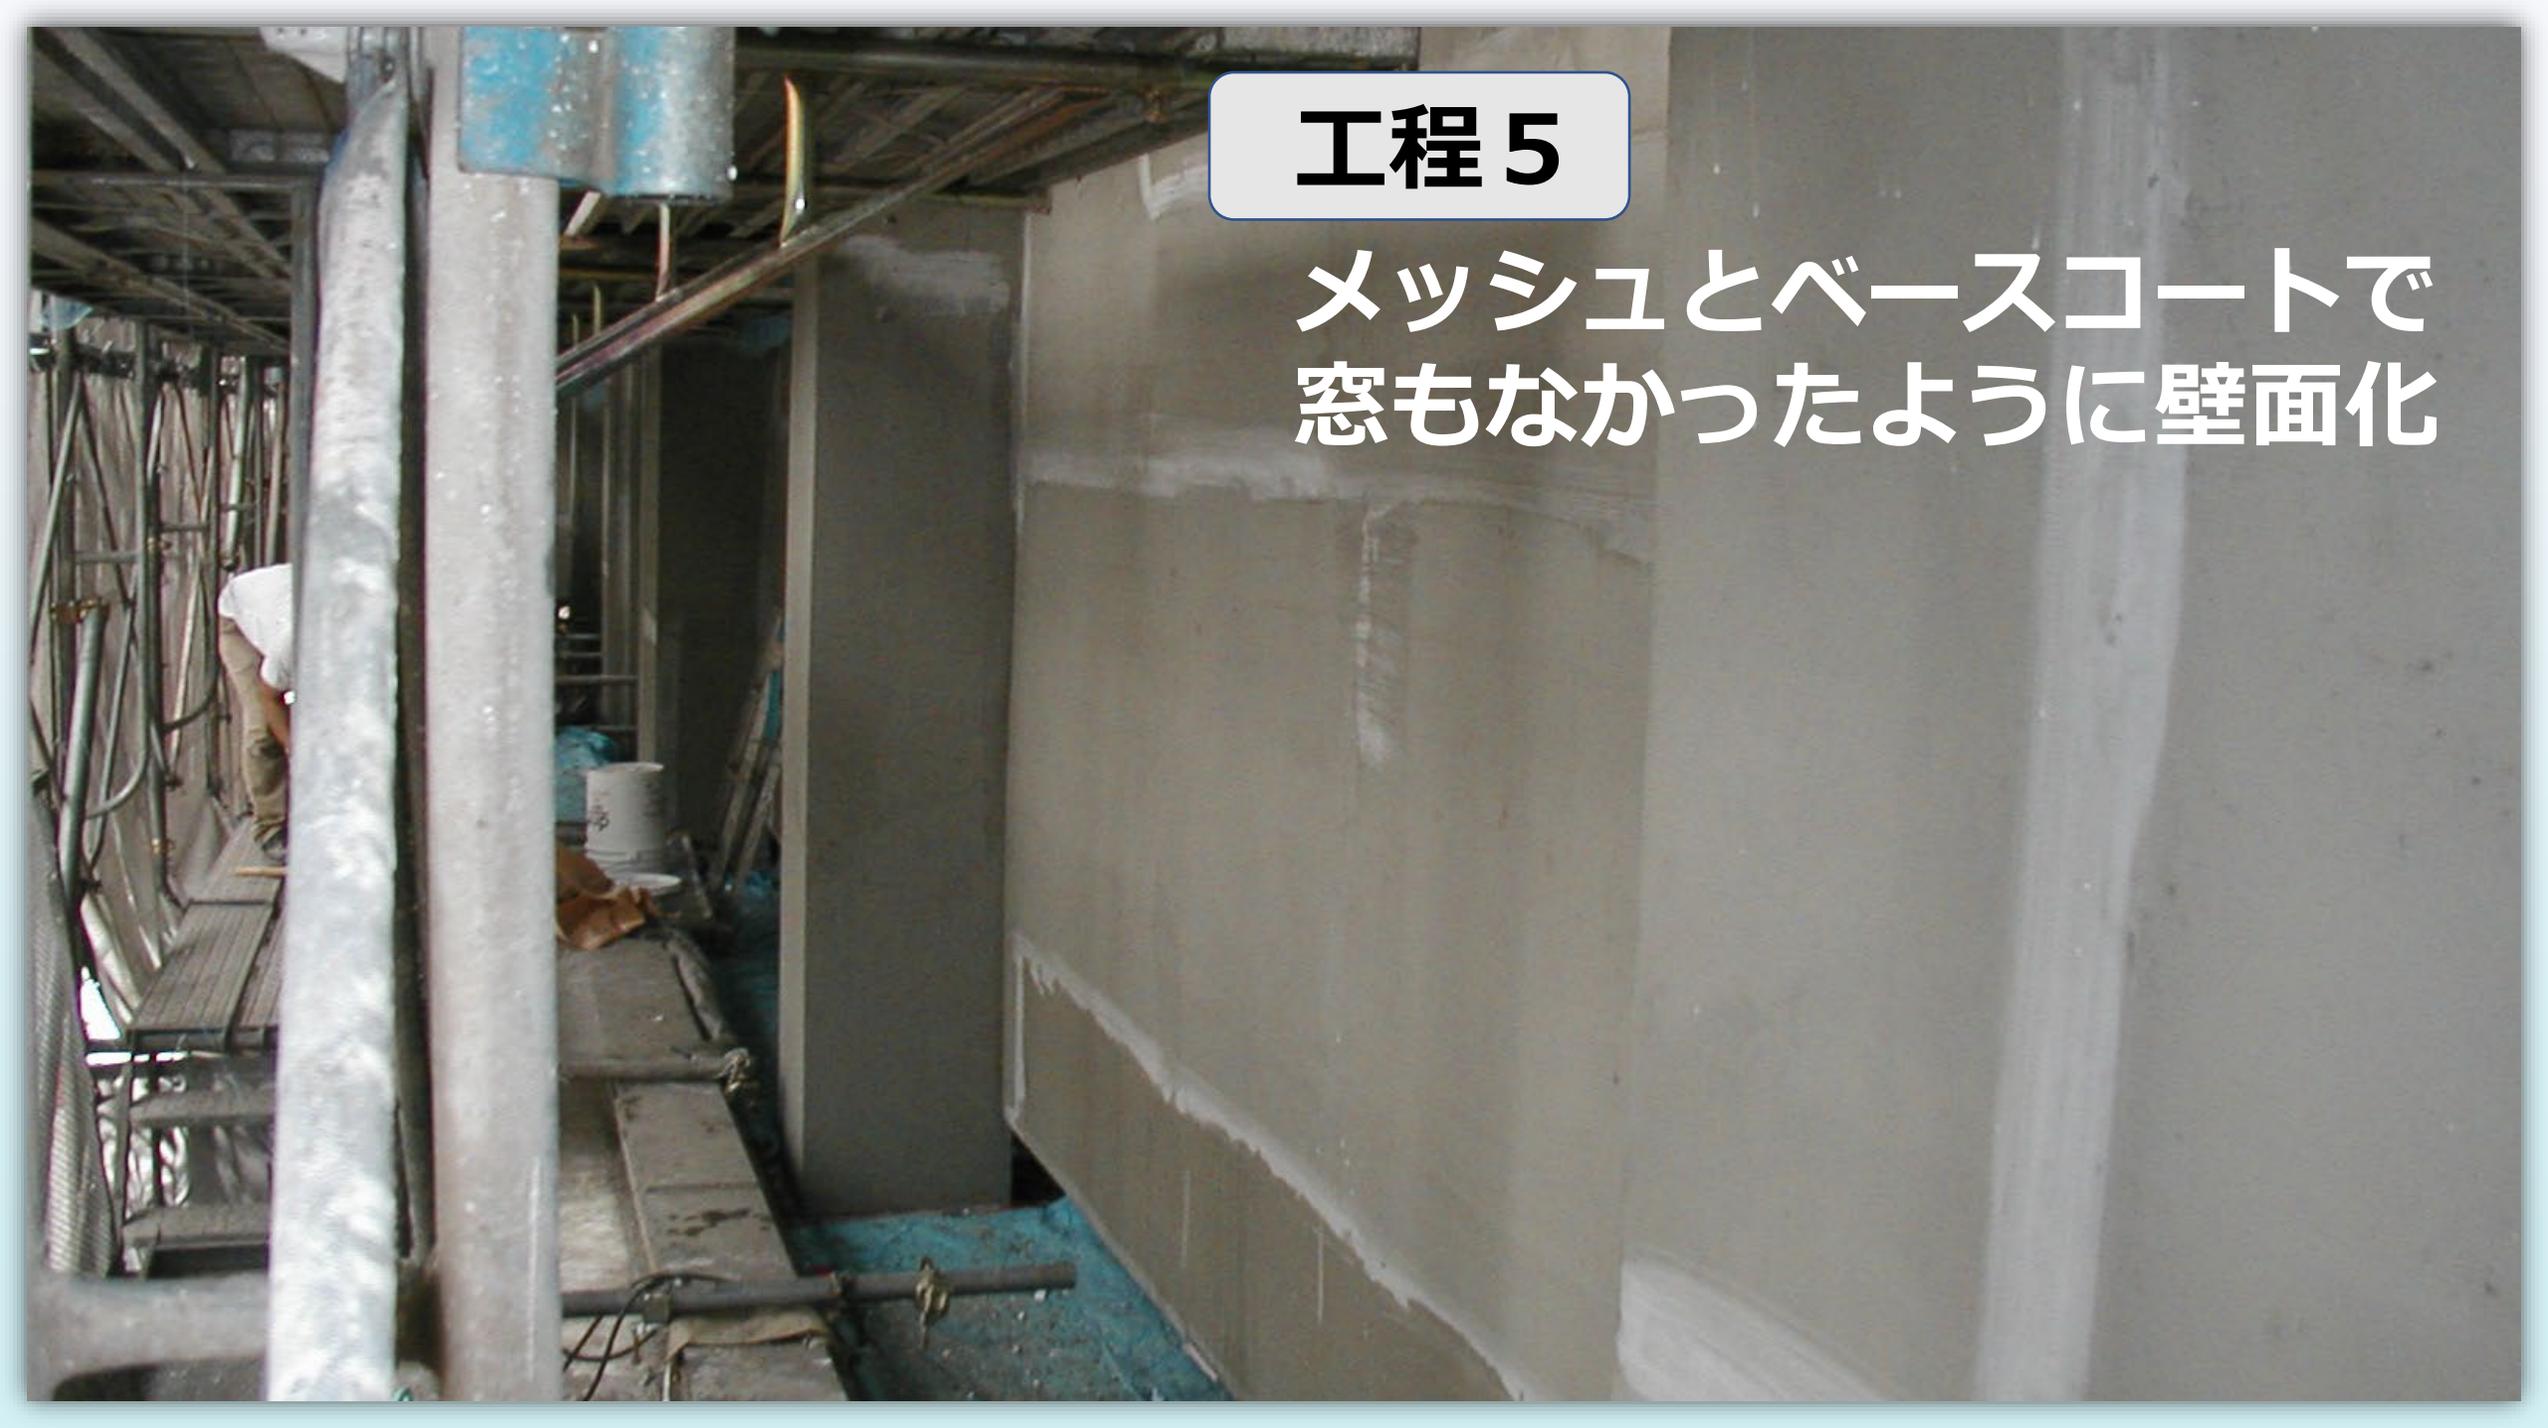
工程5

メッシュとベースコートで
窓もなかったように壁面化

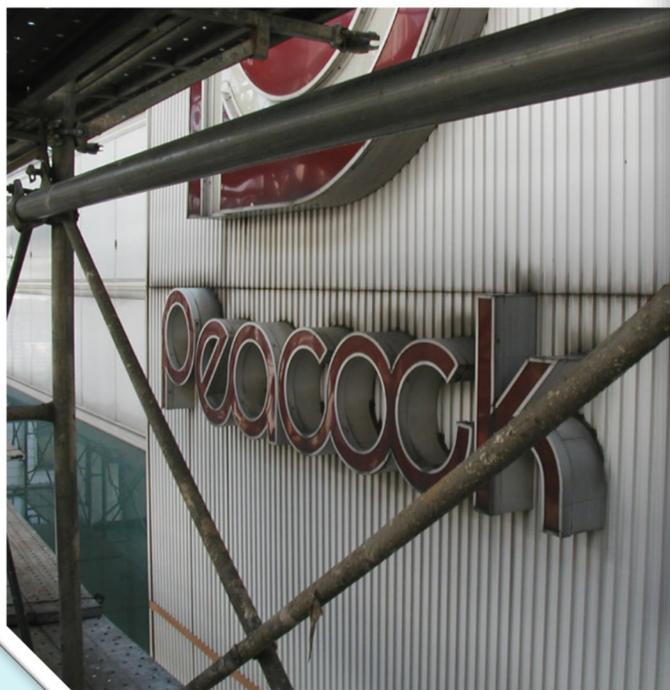
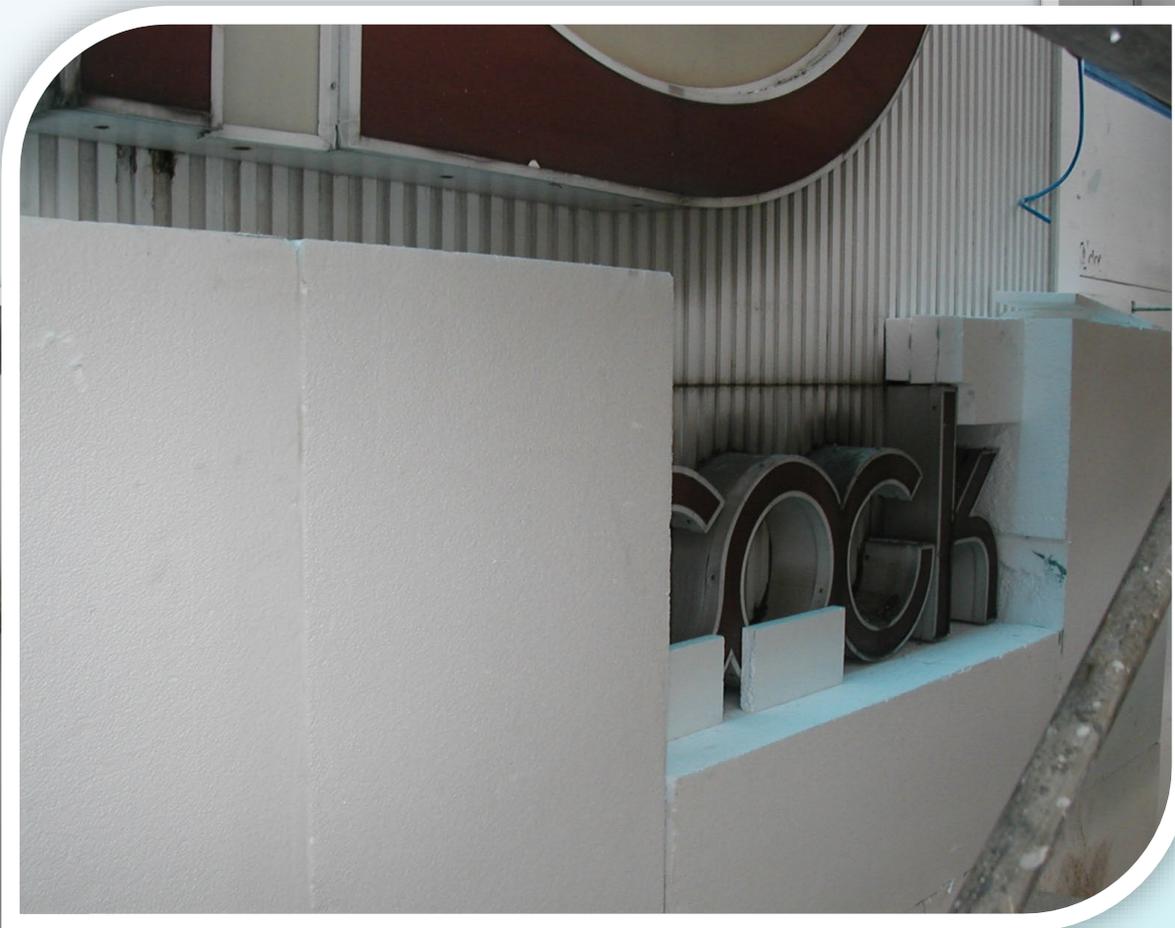
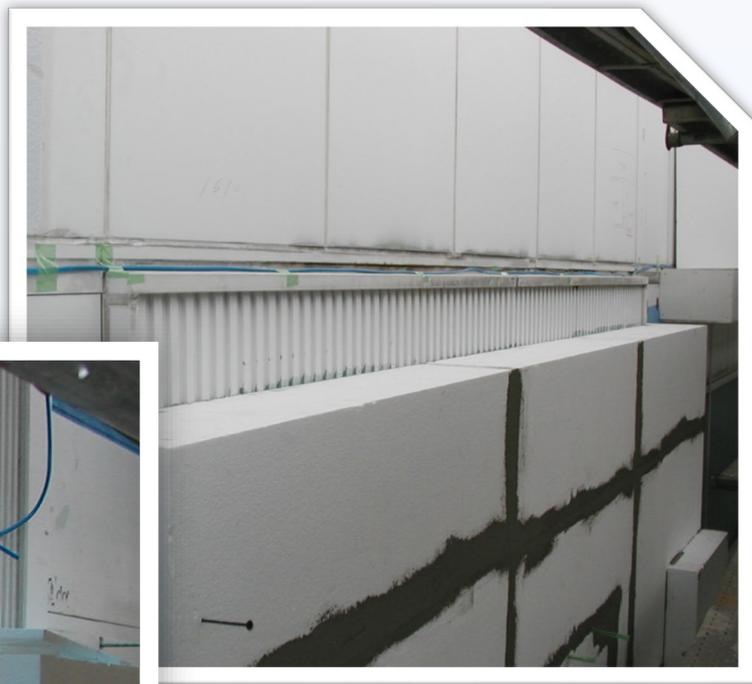
工程 6

看板も取外すことなく断熱材EPSの取付けで簡単に壁面化

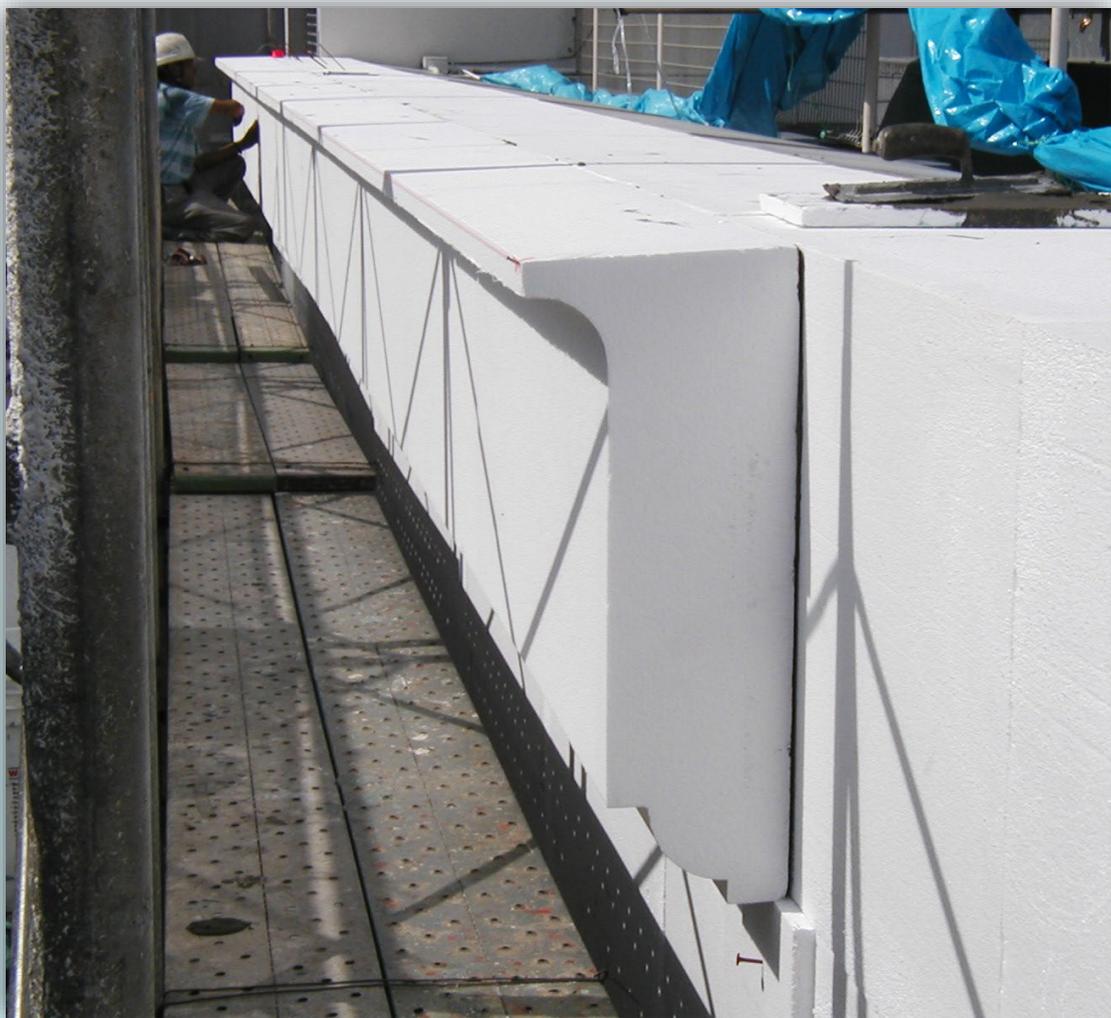
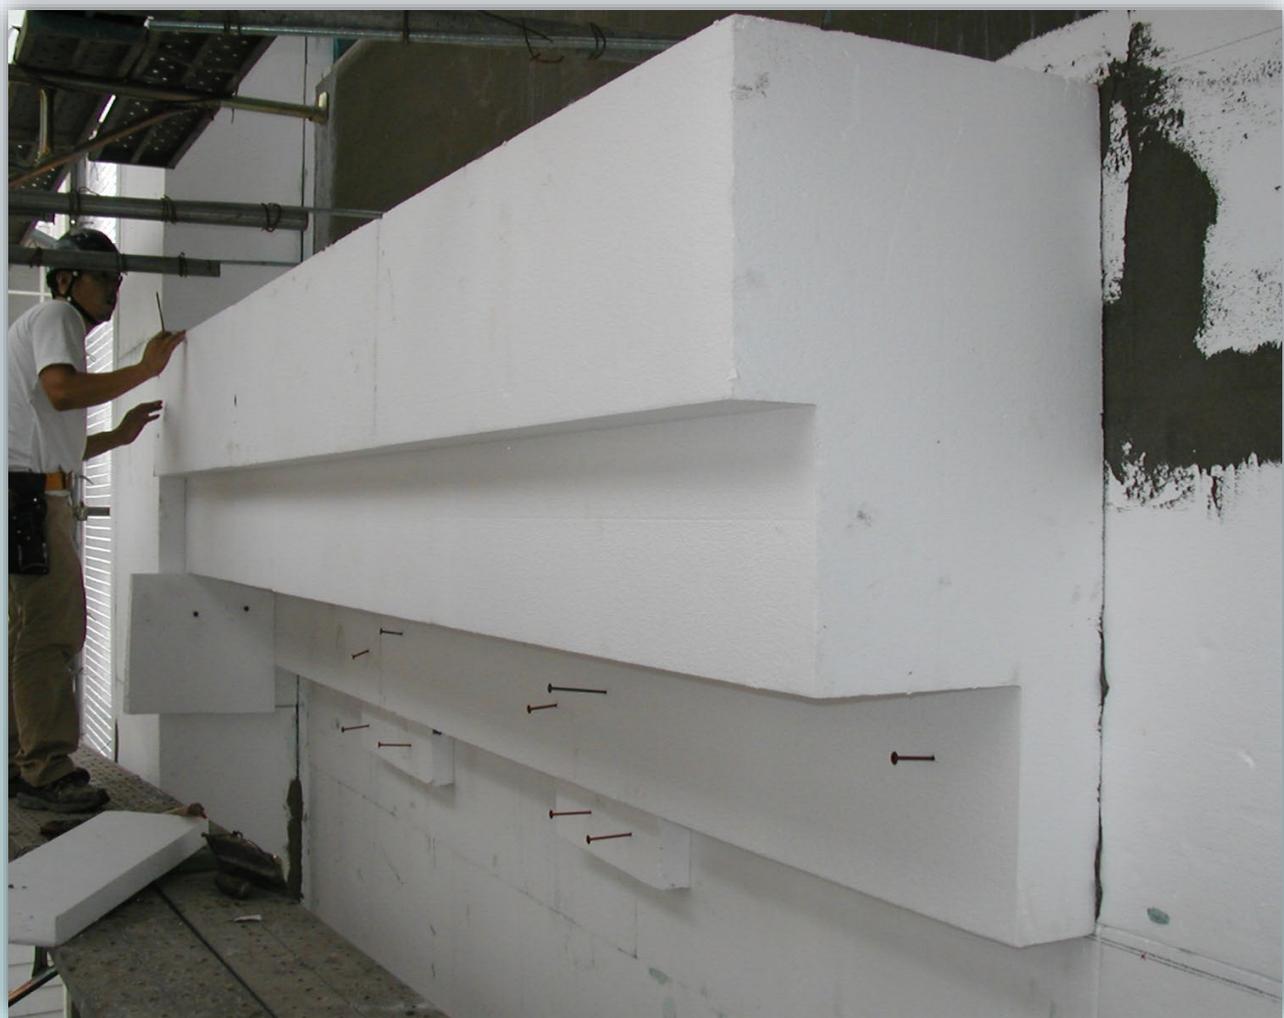
工程 7

断熱材EPSで巨大モールディングも簡単に取付け

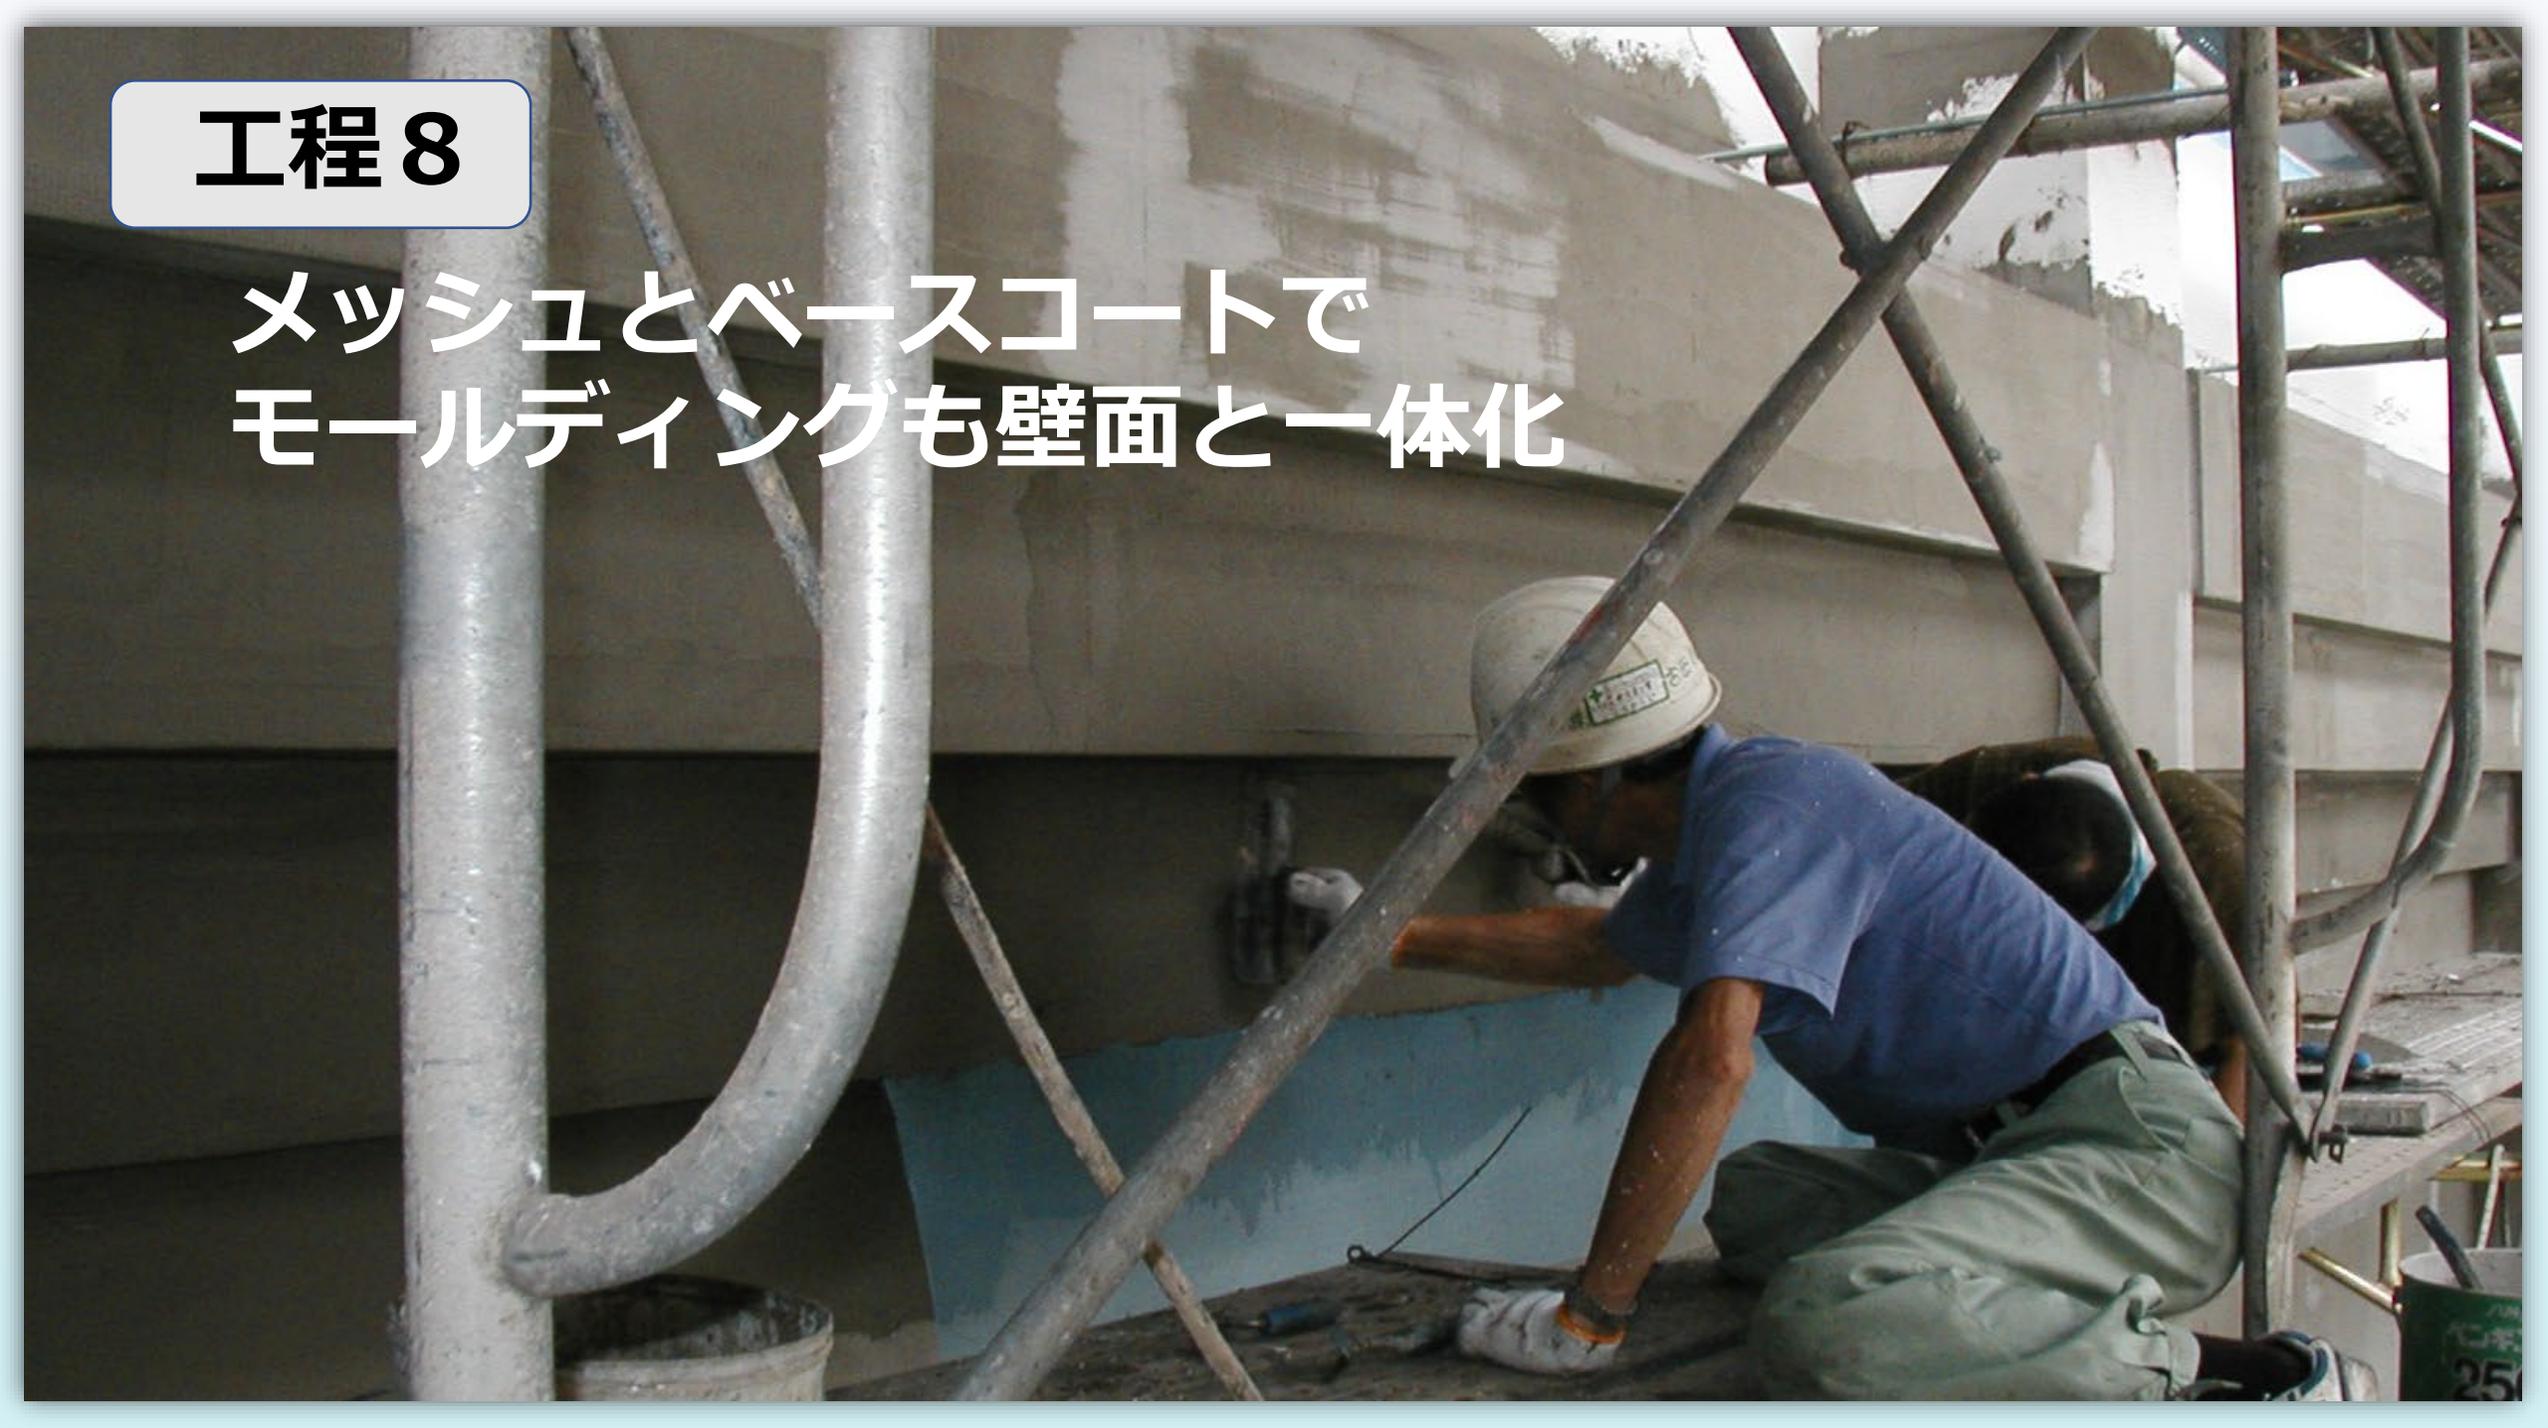
工程 8

メッシュとベースコートで
モールディングも壁面と一体化
