大丸ピーコック EIFS-J改修工事

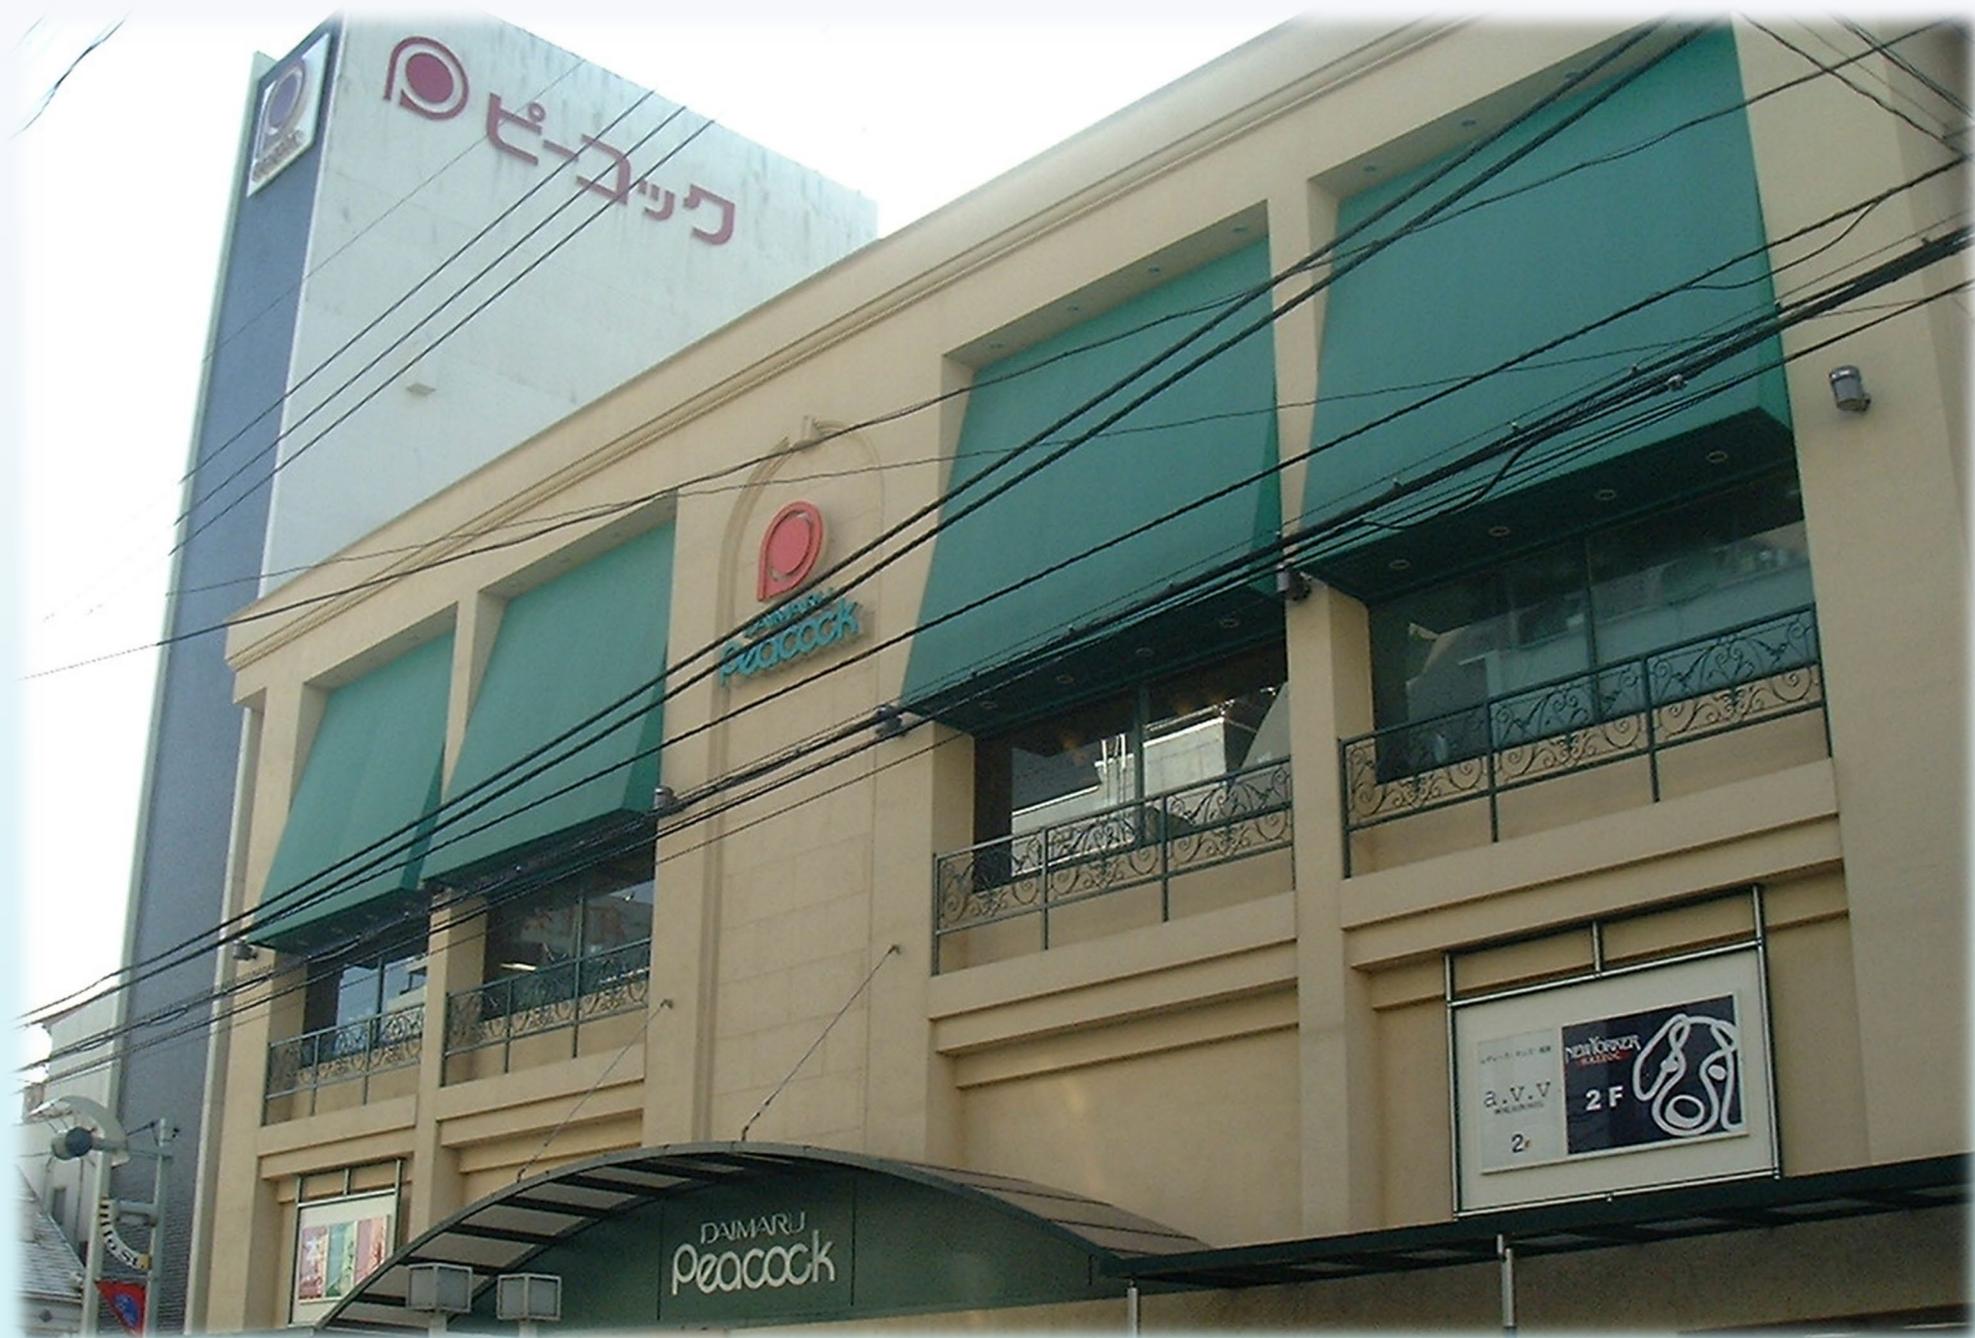
完 成
